MDPA News

April 2020

Maintenance Induced Emergency

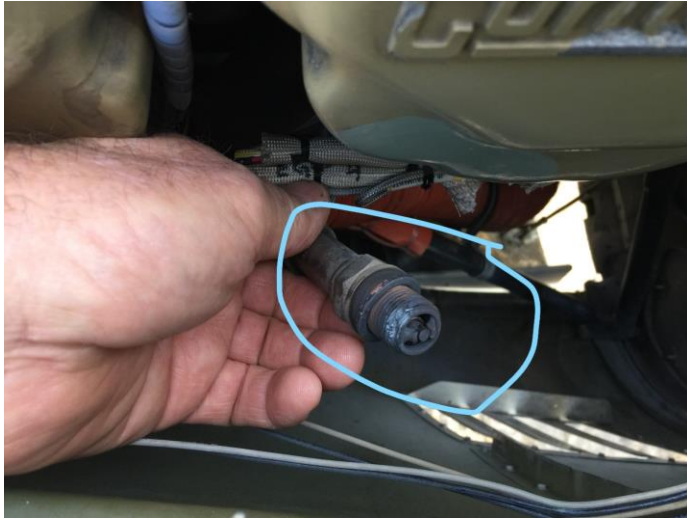
Once on the ground, I removed the upper half of the cowling and noticed the lower left middle sparkplug was hanging by the ignition wire. That was the source of the problem. I assumed that the cylinder head broke apart but could not see under there without removing the lower half of the cowling. It was getting dark and Rick Arias came to the rescue and gave me a ride back to CCR.

The next day I went to the airport with my wife and some tools and removed the lower cowl. I received a lot of help from the local pilots there and the airport caretaker "Don" (this is a private airport). Upon closer inspection, the cylinder head was intact, the sparkplug hole was intact, yet the spark plug was not in the hole. After looking into the cylinder with a borescope and doing a compression test with my thumb over the spark plug hole it seemed like the cylinder was normal but just needed a new spark plug. The old spark

plug that was hanging from the ignition wire was damaged at the end, it appeared as though some welding had taken place at the tip (See pic). Don secured a used spark plug from one of the local pilots who removed it from his plane (he said he was getting ready to change them but still an extraordinary gesture). This is a very friendly airport.

The only logical explanation was that the last mechanic to touch that plug did not torque it properly. The plane had been in the shop about 20 tach hours before the event. Part of the shop work was to install CHT temp probes on all 6 cylinders. The CHT temp probes on the O-470 are about $\frac{3}{4}$ inches away from the spark plug therefore it was surmised that the shop removed the plug and failed to reinstall it properly.

The used loaner spark plug was installed, and everything was normal except for some minor damage to the ignition wire (still passed the mag check). I flew the plane home to CCR and the next day my mechanic looked at it, put in a new plug (the loaner plug was worn), checked the torque on all the other lower plugs and everything checked out ok.

After a lot of emails, the shop acknowledged that all the lower plugs were removed but that the mechanic's notes stated that all the plugs were "reinstalled and torqued". Since the cowling had not been off of the engine in the 20 hours since the plane had been in the shop, it was clear the shop screwed up (at least to me). The only remaining damage is the damaged ignition wire and I am still working with the shop to find a reasonable solution, which seems to be to install a new harness (the shop is resisting the harness solution).
